California Water Research Technical Memo

July 2018

Dr. Clyde Thomas Williams

Under-Seepage and Seismic Safety Issues at Clifton Court Forebay

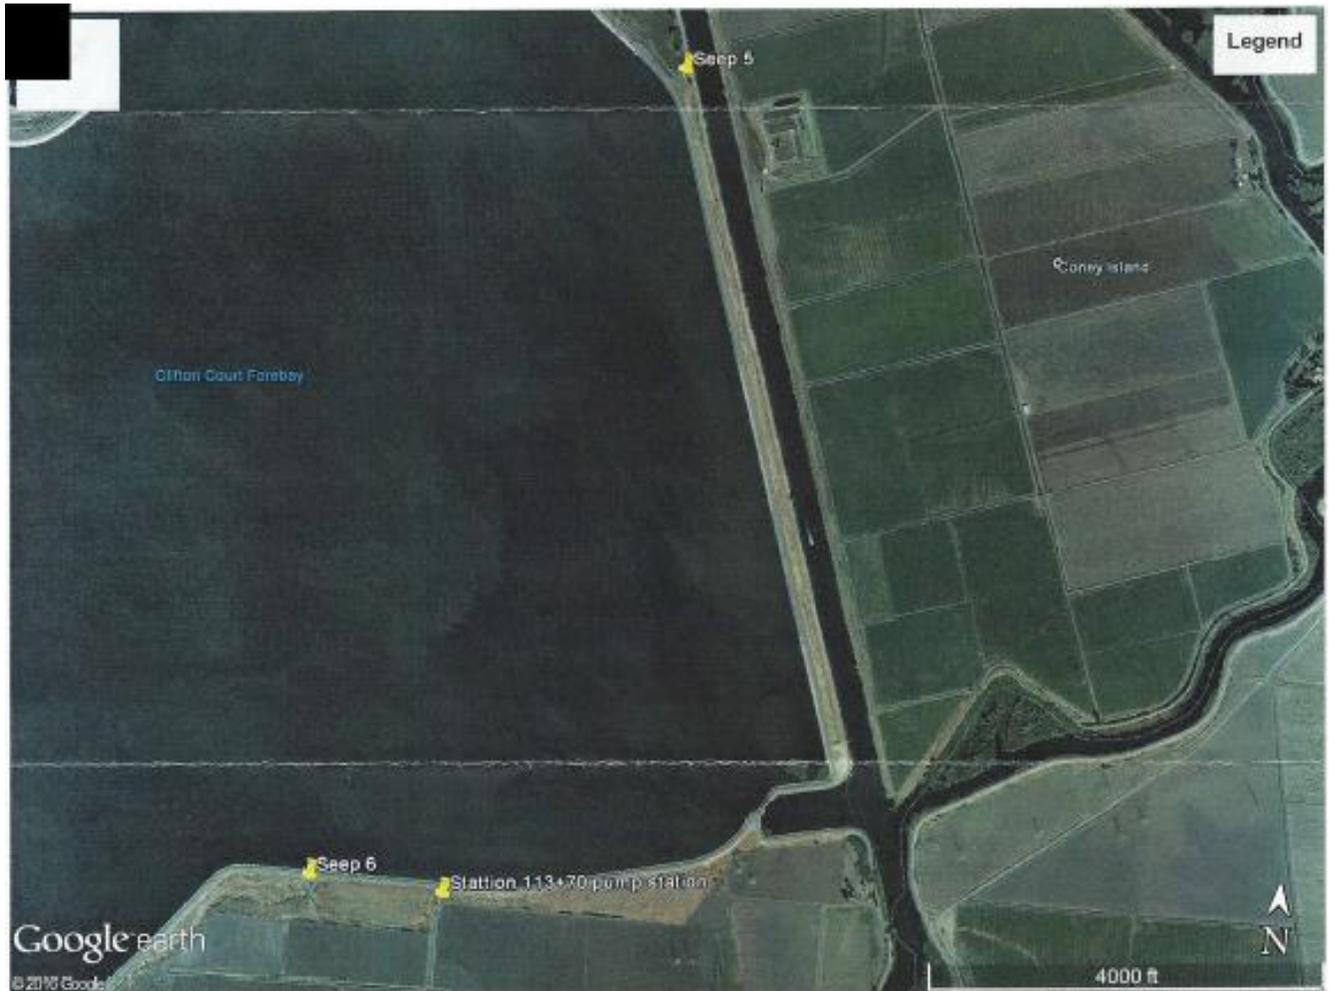
2 Closeup of Clifton Court Forebay

Specifically, DWR staff inspected our pump station that is near your property and identified as "seep 6" on the attached map. The inspection found that the seep pump, the seep well, and the standing groundwater within our seep basin is fully operational and operating efficiently. The seep basin is currently at the level it is supposed to be.

Based on the Field Division staff investigation, it does not appear that DWR facilities are a source of seepage on your property.

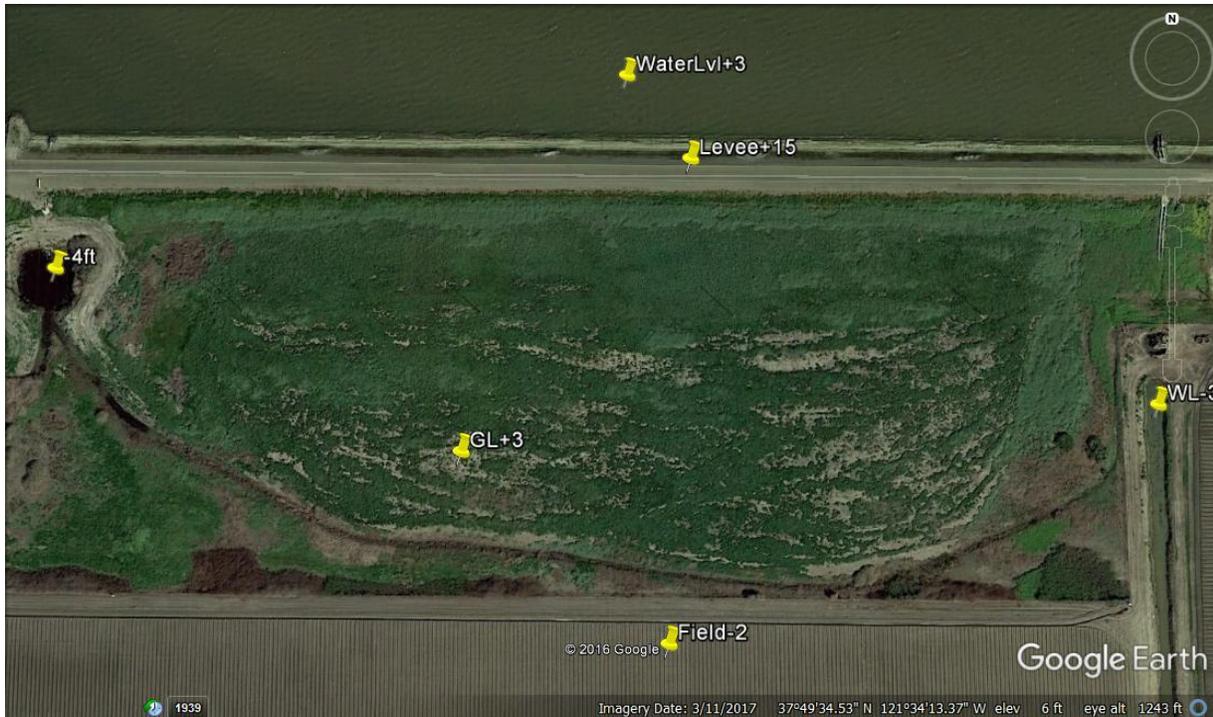
3 Satellite Photo of Forebay Embankment / Levee
 Source: Google Earth

Showing

Seep 6

Seepage Field

Drain

DWR's Delta Field Division did not provide any project design, operating conditions, or other explanations of why "normal water" levels in the seep basin would be inconsistent with under-seepage onto Ms. Womack's property and potential seepage flows, nor was information provided about seepage flow rates and paths to the seepage drain.

- (1) Implement an appropriate seepage and soil moisture monitoring system (including satellite images), which meets the standards in FEMA's guidelines on Evaluation and Monitoring of Seepage and Internal Erosion.
- (2) Investigate and analyzes under-seepage from Clifton Court Forebay;
- (3) Develops seepage model(s) based on current understanding of seepage in the Delta and evaluate risks to the embankment and surrounding lands;
